Trans Mountain Expansion Project – Westridge Marine Terminal Visit

Date	2019-11-25		Time on site	0915	Time off site	1230
DFO attendees	S.W and W.B.					
IAMC attendees One Indigenous Advisory Monitoring Committee (IAMC) monitor (J.H)						
On-site contractor/equipment		Role				
Trans Mountain		Site Management				
KLTP		Prime construction contractor				
Triton Environmental		Fish salvage activities in cell 10.				
Hemmera		Water quality monitoring during riprap excavation along foreshore				
DB General DB Bremerton DB Olympia		Derrick barges (DB) General was working offshore splicing breasting dolphin piles 7 and 8. DB Bremerton and Olympia were working in the nearshore on sheet pile cell 10 (getting ready to remove template) and cell 8 (threading sheets), respectively.				
Burrard (crawler crane)		Working offshore and conducting preparatory works for construction of the superstructure (e.g., caps, decking).				
JJM Barge		Working from a barge to remove existing riprap along the western part of the foreshore. Excavated riprap placed on separate spoil barge.

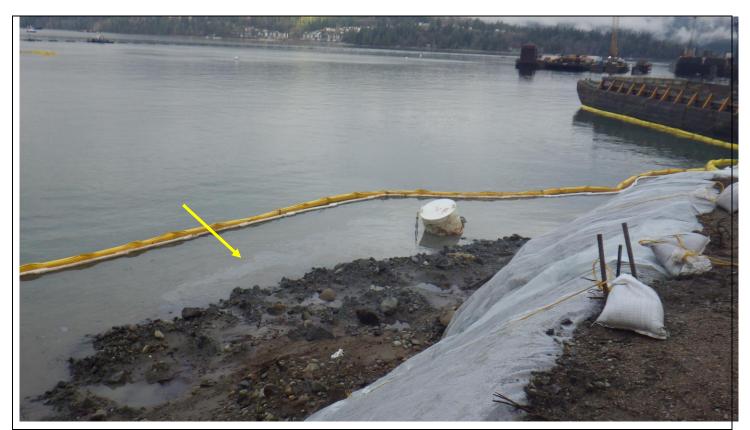
Photo 3. Naturally occurring sheen observed floating on surface of the water (yellow arrow points to sheet).

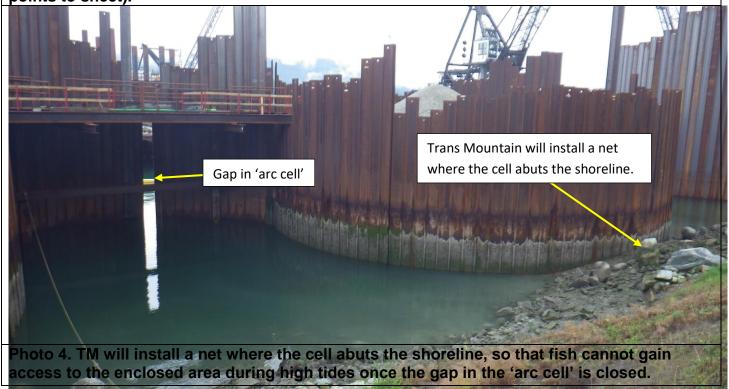
- -DFO and the TM EI discussed installation of a fine-mesh net barrier to prevent fish from becoming trapped within the shallow area located between cell 6 and cell 7 (i.e., within the 'arc cell'), once the gap in sheet pile cell 6a is closed (Photo 4). Fish may otherwise gain access during high tide when water levels are high enough to flood the area where sheet pile cells 7 and 8 abut the foreshore. The TM EI said they will provide specifications on the net to DFO.

• On November 26, 2019, Trans Mountain provided the requested specifications for the nets being used to isolate the area enclosed by the arc cell, once the gap in the cell is closed. The nets will be secured to the southern sides of the circular cells and will extend to shore, isolating the arcs. The nets are 1/8-inch mesh and measure 15 feet deep by 35 feet long. They have cork floats at the top and a lead line at the bottom.

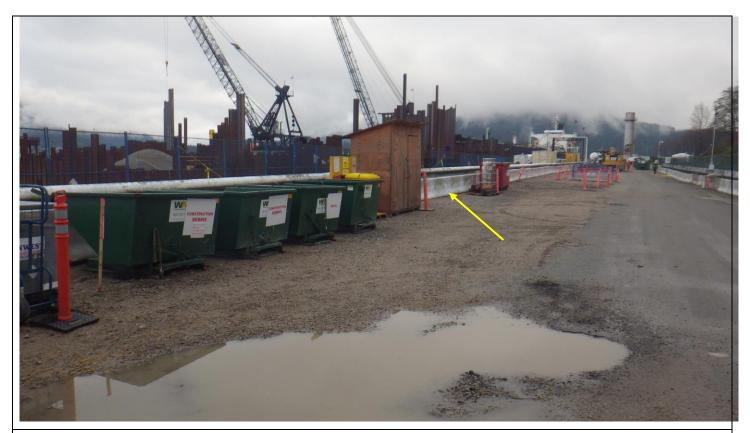
- -Observed installation of three layers (lock blocks [Photo 5], a berm, and a sediment fence, Photo 6) along the foreshore to capture potential run-off during concrete works that will commence during the next few weeks.

Photo 5. White concrete lock blocks (yellow arrow) placed along shoreline to avoid runoff into the marine environment from the area where concrete column mixing will occur.

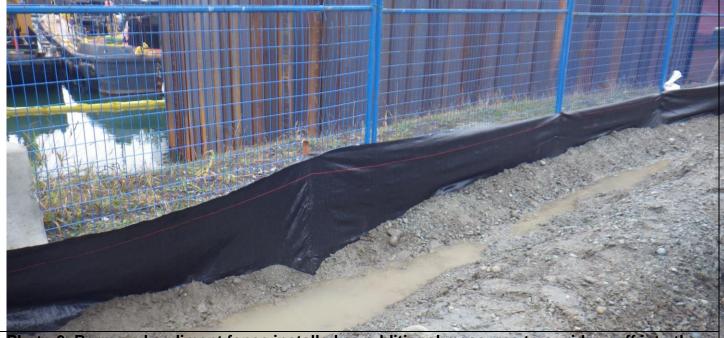
Photo 6. Berm and sediment fence installed as additional measures to avoid runoff into the marine environment from the area where concrete column mixing will occur.
