Environmental Surveillance Activity

Project Name	Trans Mountain Pipeline Reactivation
Parks Canada Internal File	J17-015
Project Proponent	Trans Mountain Pipeline ULC (TM)
Prime Contractor	Simpco Leducor Limited Partnership (SLLP)

Event Type	Parks Canada - IAMC Joint Field Inspection
Date	June 29 – 30, 2020
Location	Various locations within Jasper National Park
Environmental Surveillance Officer(s)	<ul style="list-style-type: none"> • Jasper National Park ESO • Indigenous Monitor - Lac St Anne Metis • Indigenous Monitor – Ermineskin Cree Nation
TM or SLLP representative	<ul style="list-style-type: none"> • Trans Mountain Indigenous Monitor (accompanied inspection for all of Day 2)
Description of Field Inspection	<ul style="list-style-type: none"> • Site visits of Construction yard • Post Construction sites along Caledonia and Snaring • Active construction Highway 16
Activities Monitored	<ul style="list-style-type: none"> • Construction • Construction yard operation and maintenance • Restoration

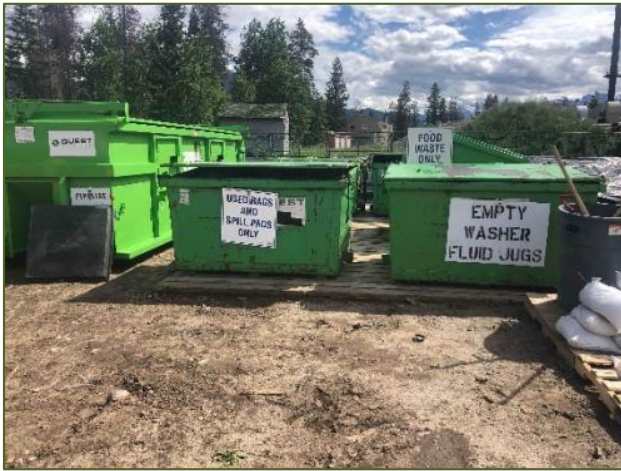
Picture #1

- Labeling on waste disposal containers present.
- Proper disposal of correct waste materials and well organized (pic # 1,2).
- Extra containment under fuel tanks and around fueling area (pic # 3).
- All machinery observed had proper second containment (pic # 4).
- Spill kits present in machinery observed.
- Yard was clean and well organized.
- Fencing around yard in place to keep out wildlife.

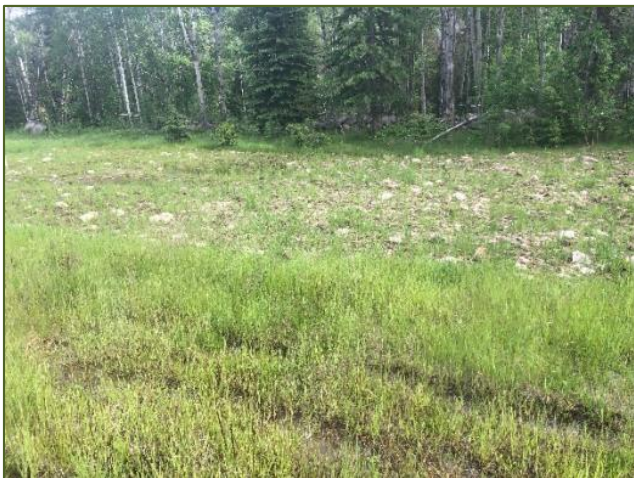
Picture #5

- Dig 26 (pic #5)
- Dig 27 - deer and elk tracks observed in the area.
- Dig 28 – some grass starting to grow.
- Fractured ground running along right of way.

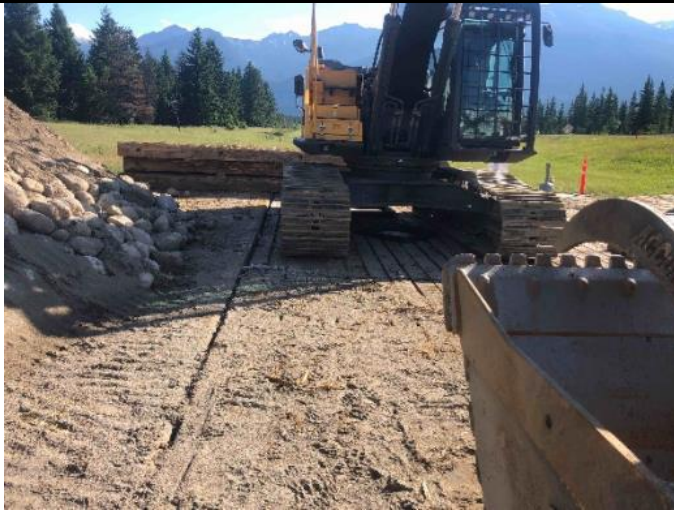
Picture #6

- rig mats being used for equipment with geotext underneath (pic #6).
- Fencing around exposed hole with signage for open excavation.
- Elk and deer tracks in the area.

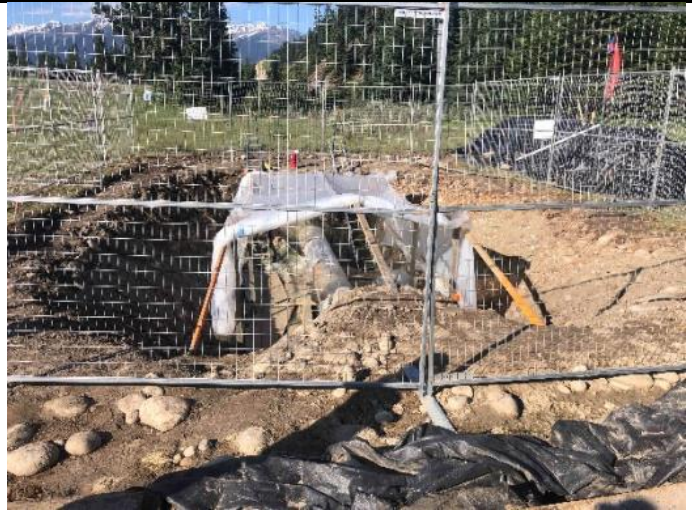
Picture #7

- Coal seam around pipe is making it harder to expose.
- Proper fencing and signage around open excavation (pic # 7).
- Site is right beside a rock face with netting on the face to hold back any loose debris.
- Douglas Fir tree on top of rock face is tethered back for safety and to preserve the tree (above work site).

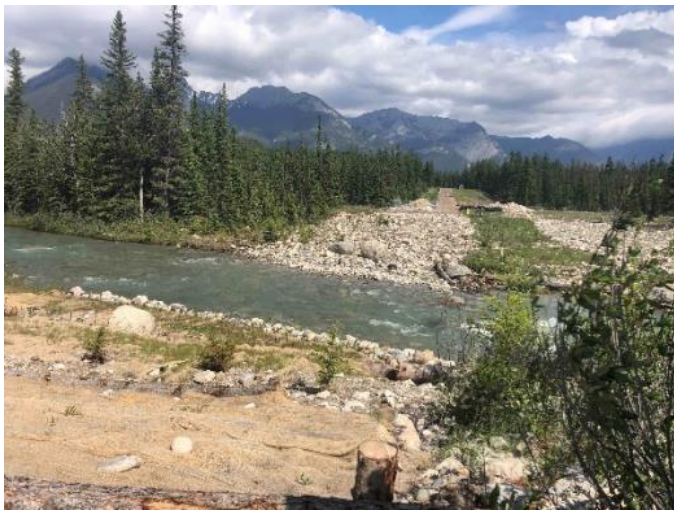
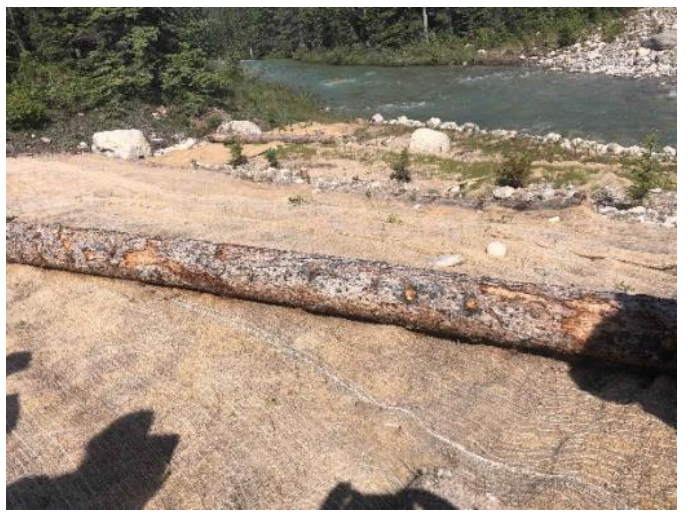
- Coconut matting along rivers edge for erosion and grass growth (pic # 8 & 9)
- The larger area away from the river had recently been reseeded, no grass sprouting yet
- TMX have removed some larger rocks that had previously been placed in the contributory as debris had been hanging up on them
