# MARINE TRANSPORTATION SAFETY INVESTIGATION REPORT M21P0297

## **LOSS OF CONTAINERS OVERBOARD AND SUBSEQUENT FIRE**

Container vessel *ZIM Kingston*  
La Perouse Bank, British Columbia  
21 October 2021

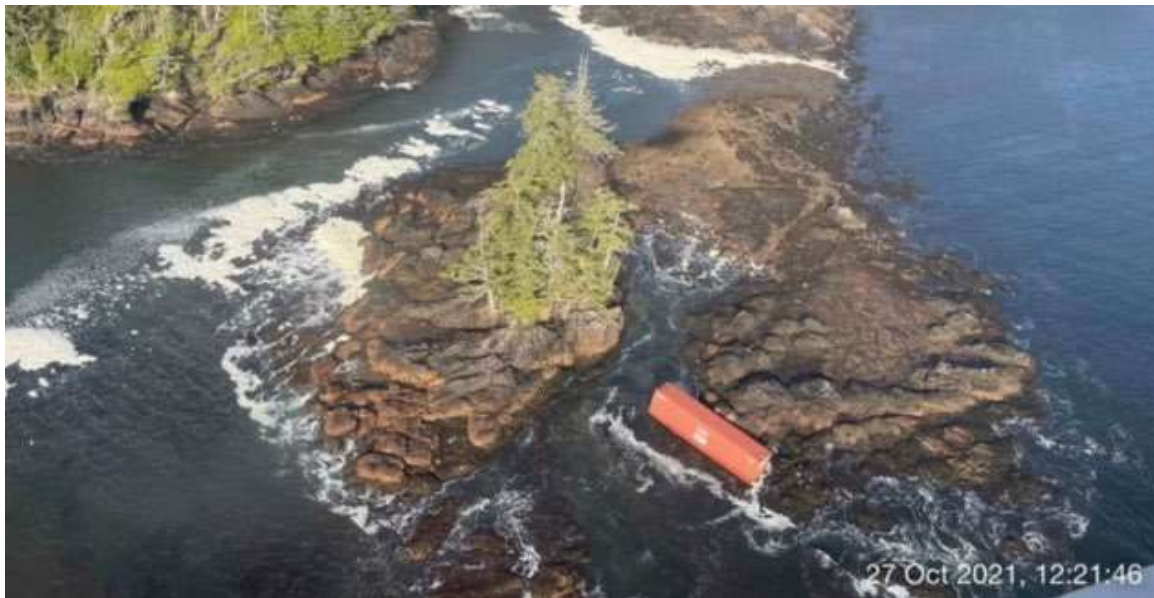
Figure 5. Aerial photo of a container from the *ZIM Kingston* washed up on land (Source: Transport Canada)

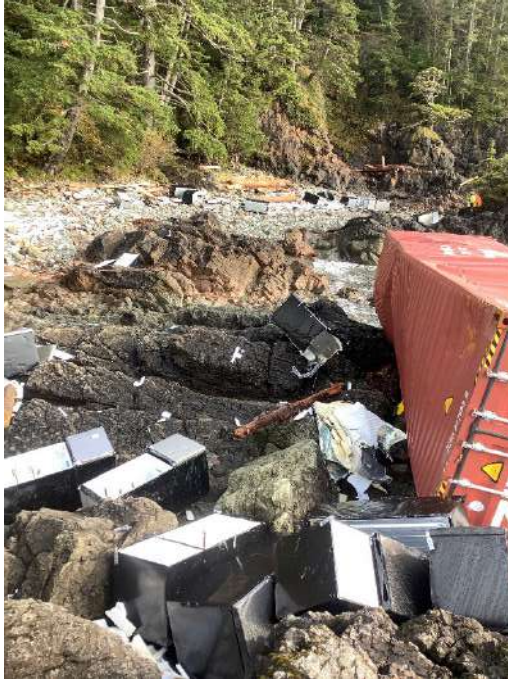
Figure 6. Photo of a container from the *ZIM Kingston* and refrigerators on the beach at Cape Palmerston, BC (Source: Pacificus Biological Services Ltd.)

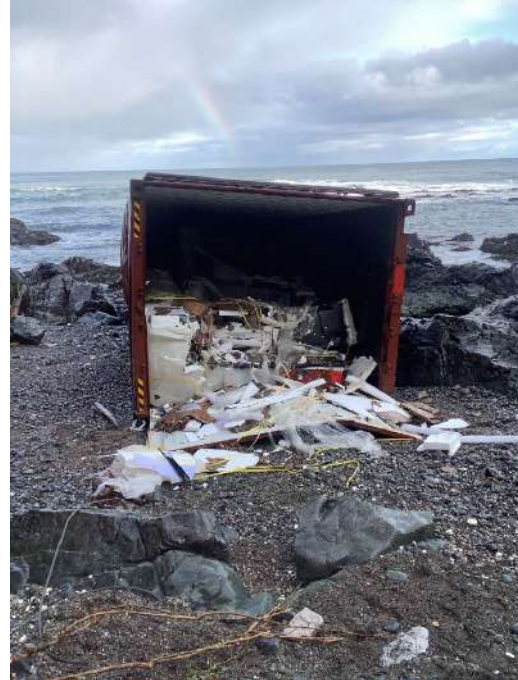
Figure 7. Photo of an open container from the *ZIM Kingston* with plastic debris inside at Shuttleworth Bight, BC (Source: Pacificus Biological Services Ltd.)

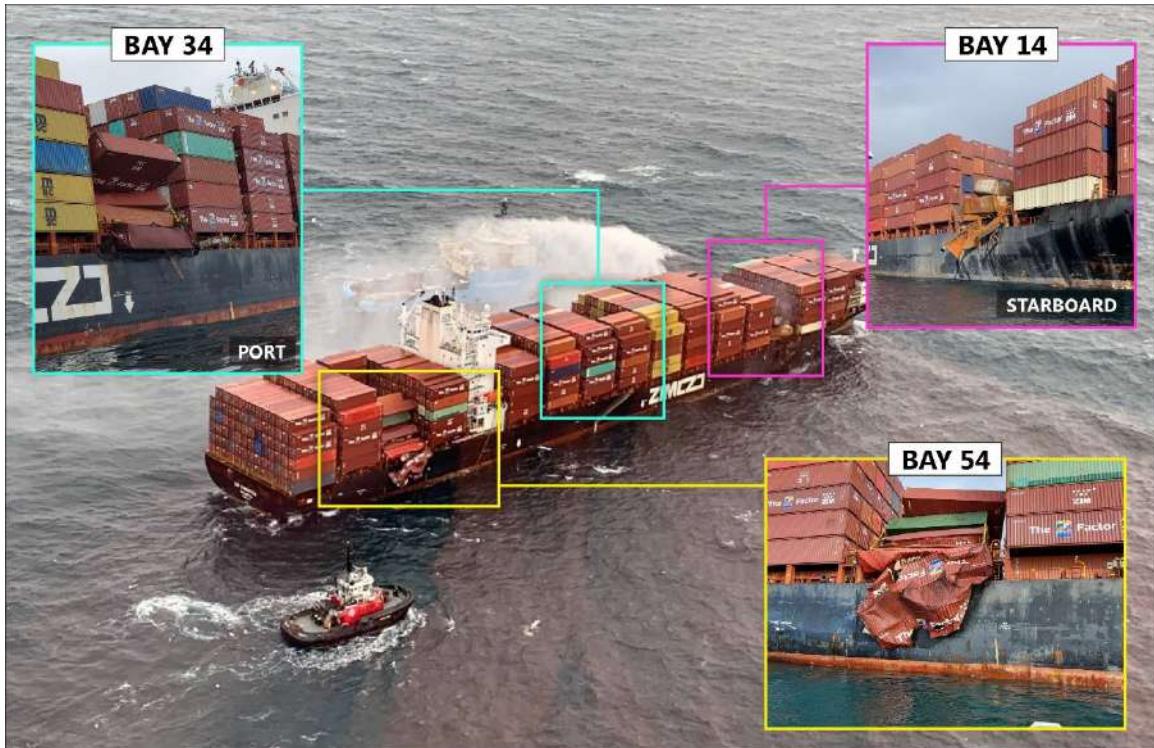
As a result of the occurrence, a total of 109 containers went overboard from 3 bays (bays 14, 34, and 54) and 53 containers on deck were damaged (figures 9 and 10). Post-occurrence examination of the containers showed that there had been fires inside 6 of the containers in bay 14: of these, 3 had held xanthates and 3 had held tires and general consumer goods. One of the hatch covers in bay 14 was bent, and the port-side accommodation ladder was also damaged.

Figure 8. Bays in which containers were damaged or lost overboard (Main image source: Transport Canada; inset images source: TSB)

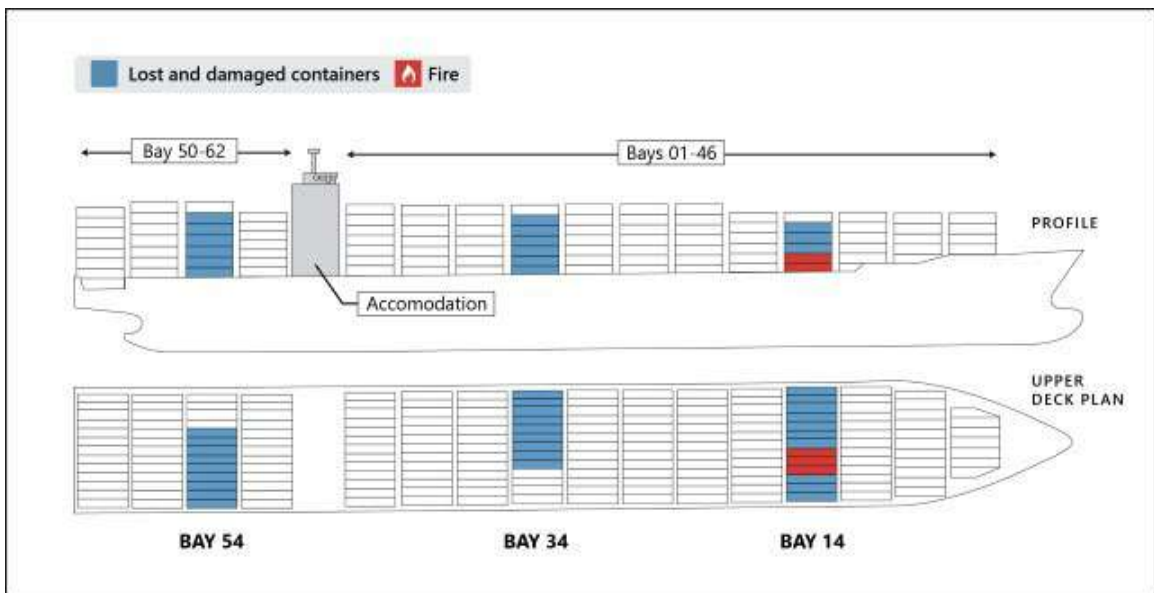
Figure 9. Bays with lost or damaged containers, as well as the location of containers that caught fire (Source: TSB)

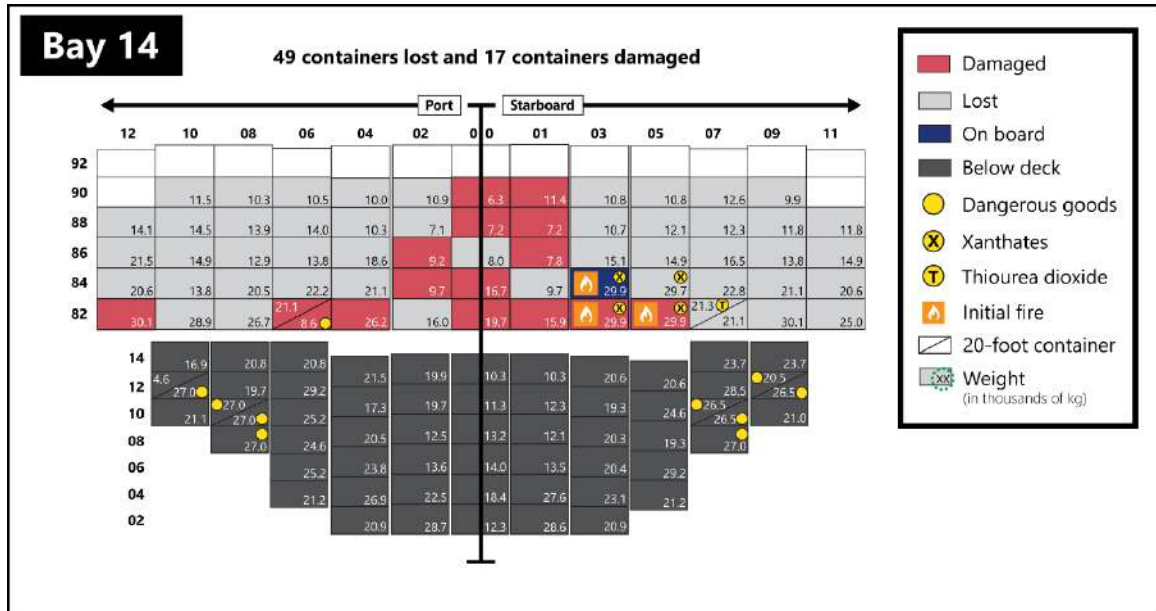
Bay 14 held a combination of 40-foot containers and 20-foot containers on deck. The 20-foot containers were stowed in pairs end-to-end, forming the equivalent length of the 40-foot containers. Forty-nine containers were lost overboard from bay 14, and 17 were damaged (Figure 10).

Figure 10. Cross-section of bay 14 showing lost and damaged containers (view from aft looking forward)  
(Source: TSB)

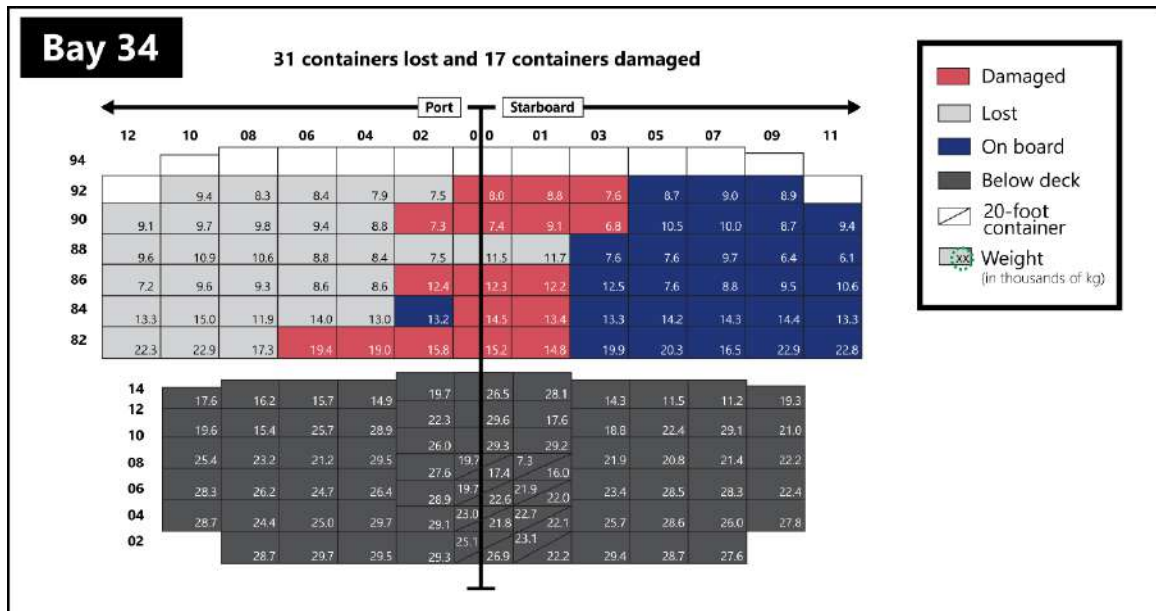
Bay 34 held only 40-foot containers on deck. Thirty-one containers were lost overboard from bay 34, and 17 were damaged (Figure 11).

Figure 11. Cross-section of bay 34 showing lost and damaged containers (view from aft looking forward)  
(Source: TSB)

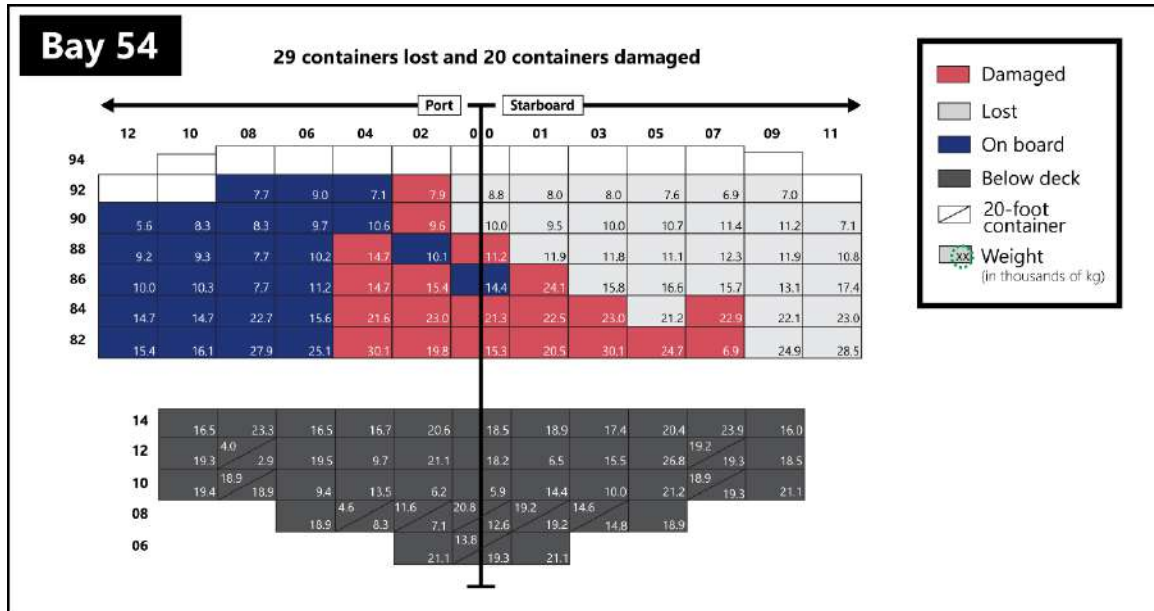
Bay 54 held only 40-foot containers on deck. Twenty-nine containers were lost overboard from bay 54, and 20 were damaged (Figure 12).

Figure 12. Cross-section of bay 54 showing lost and damaged containers (view from aft looking forward)  
(Source: TSB)

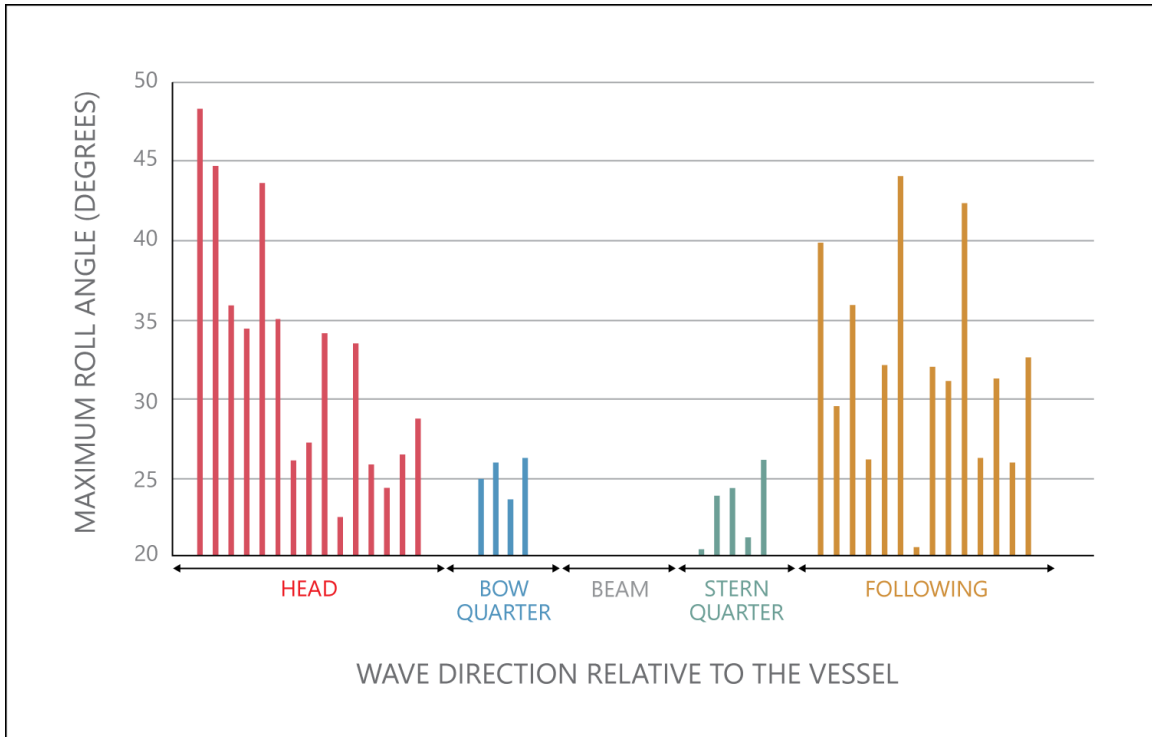
Figure 17. Test results showing roll angles greater than 20° in relation to the wave direction relative to the vessel (Source: TSB, from National Research Council of Canada data)

Analysis of the tests that resulted in roll motions greater than 20° showed that the model’s pitching period<sup>36</sup> was approximately equal to the wave encounter period and was nearly half the roll period. The ratio of roll period to wave encounter period is a key factor for the development of parametric roll resonance and indicates that parametric rolling was the cause of the extreme rolling events during the testing. Furthermore, the testing determined the range of values for this ratio, as well as for the ratio of wave length to ship length, that were found to coincide with parametric rolling of the vessel (Table 2).

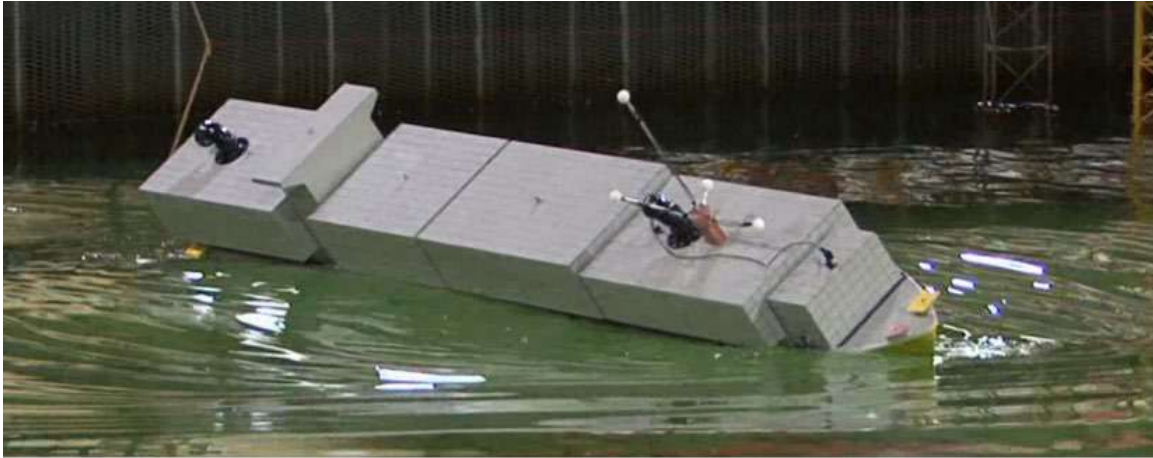
Figure 18. Still photo of the *ZIM Kingston* model rolling to large angles during tests. Note that the level of water is reaching the containers on the deck; at full scale, this would be considered a green water event (Source: National Research Council Canada)

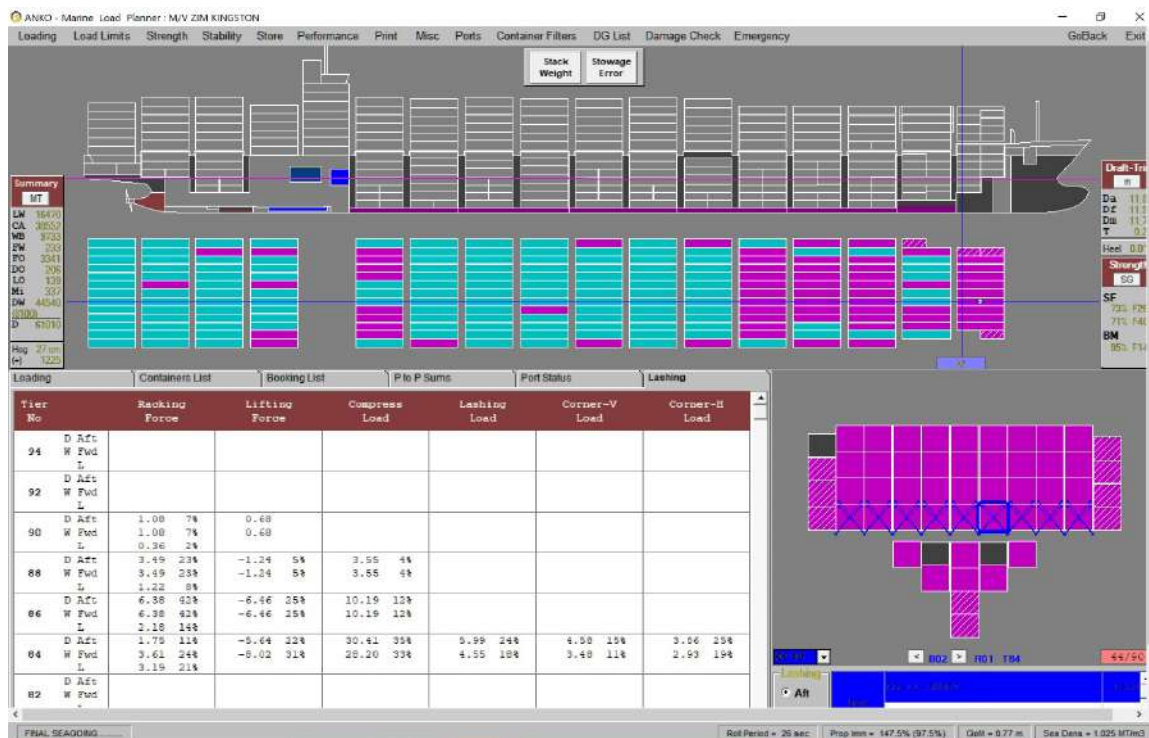
Figure 24. Screenshot of the ZIM Kingston load planning software showing containers with excessive lashing forces for the nominal roll angle (indicated in aquamarine) (Source: TSB)

If a loading plan proposed by a ZIM ship planner included containers with excessive lashing forces for the nominal roll angle, the master was to notify the ship planner, and they were to work together to rectify the issue. The SMS stated generally that the “vessel must not proceed to sea unless all lashing has been completed to the [m]aster’s satisfaction.”<sup>69</sup>

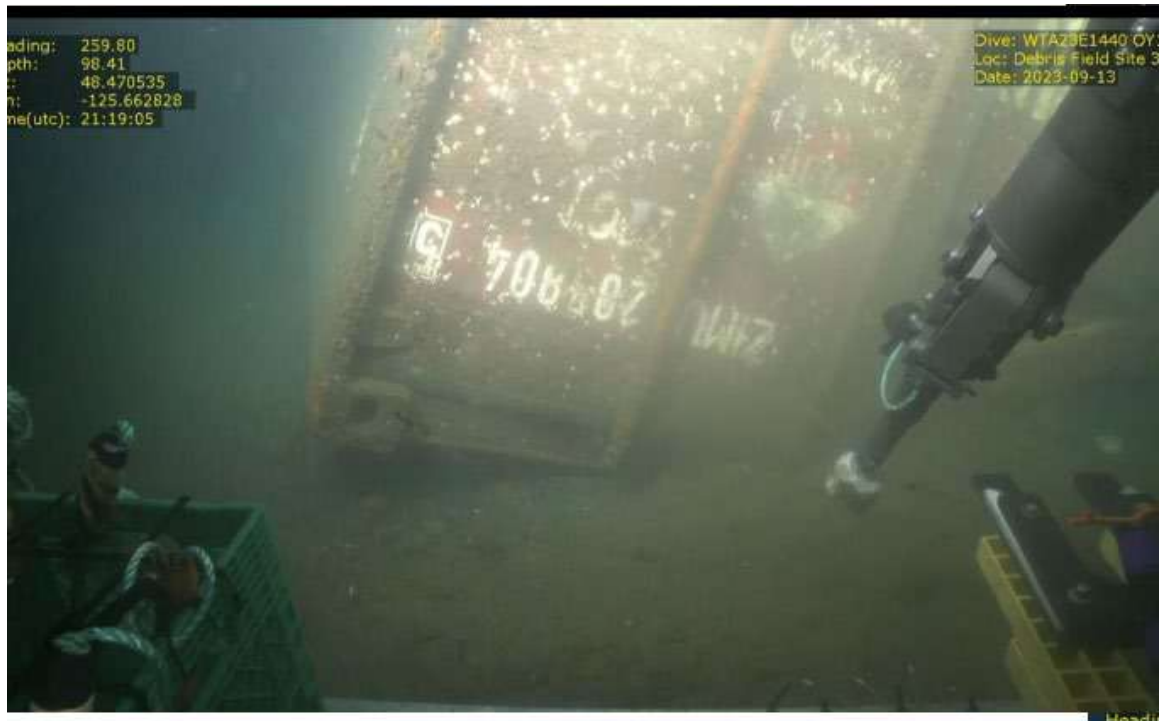
Figure 25. A ZIM container on the ocean floor (Source: DFO)

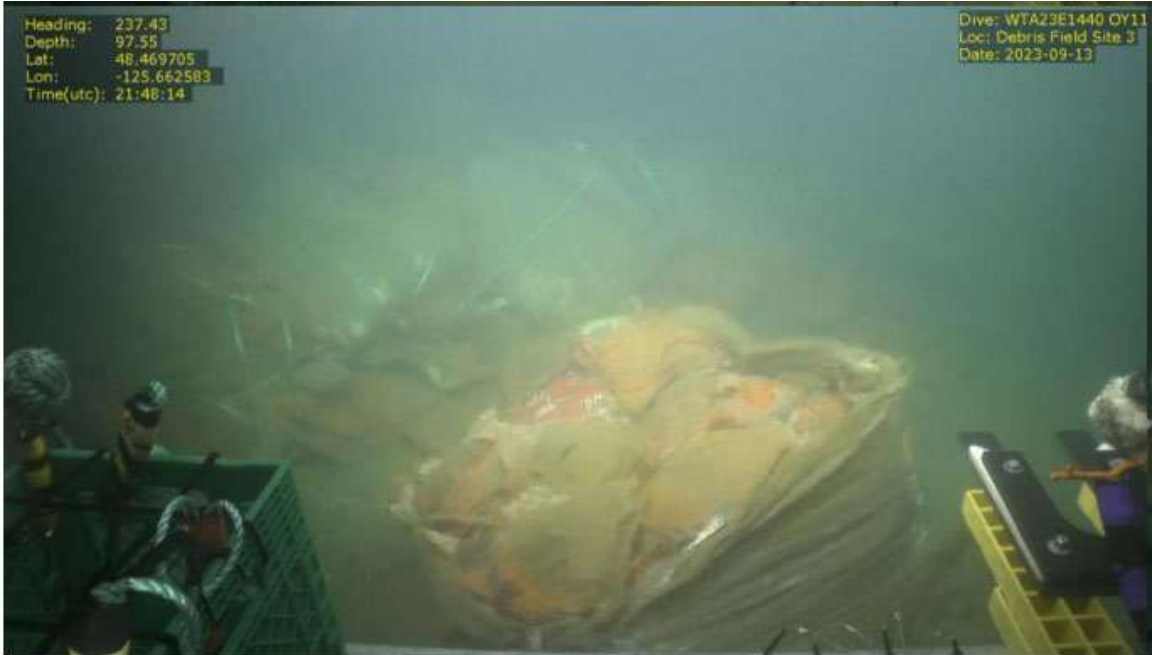
Figure 26. Plastic debris on the ocean floor (Source: DFO)

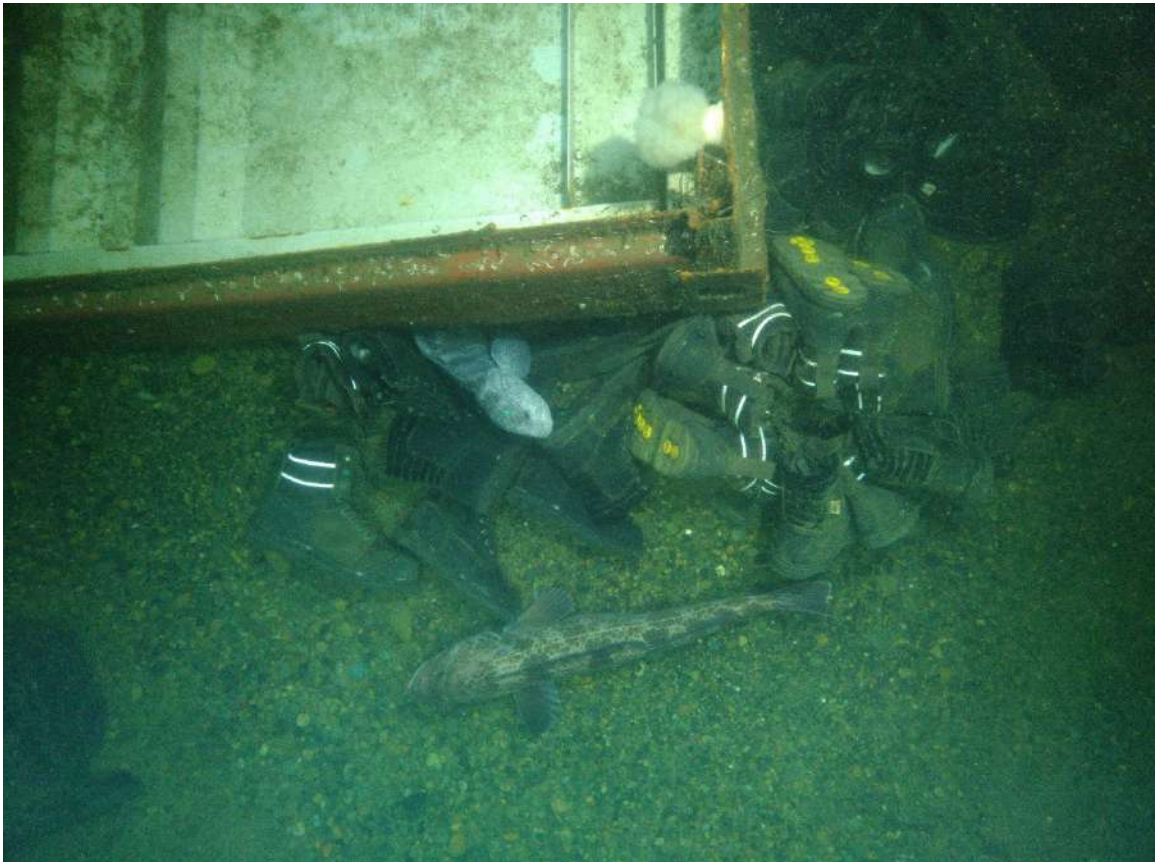
Figure 27. Boots on the ocean floor (Source: DFO)
