Site Visit Report: SV-2020-02-25

Trans Mountain Expansion Project – Westridge Marine Terminal Visit

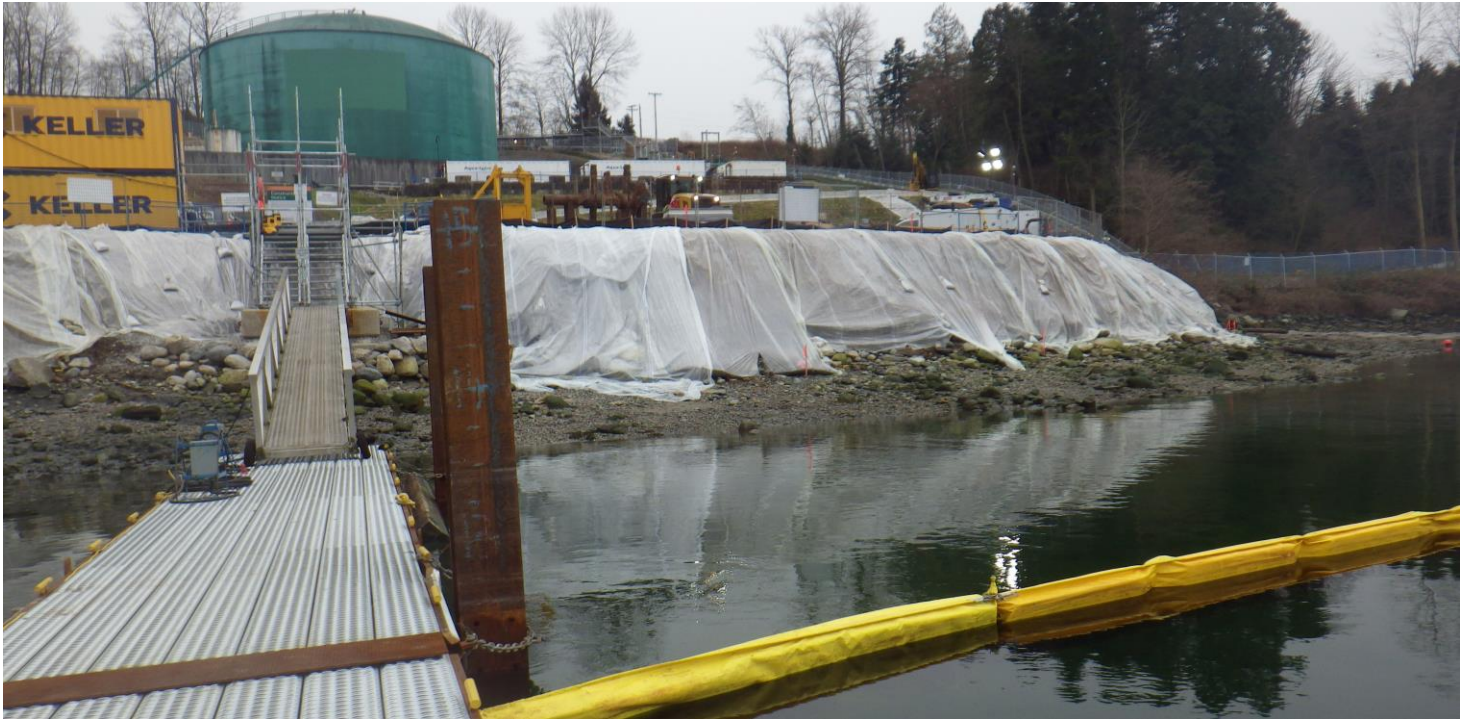
Photo 1. Polysheeting along shoreline to reduce erosion; yellow turbidity curtain in place to contain turbid water.

Time	Inspection Activity
0930	<p>DFO met representatives at the KASK site including:</p> <ul style="list-style-type: none"> • Kiewit-Ledcor Trans Mountain Partnership (KLTP) <ul style="list-style-type: none"> ○ Environmental Manager [A.A] • Trans Mountain (TM) <ul style="list-style-type: none"> ○ Chief Environmental Inspector [B.J] ○ TM Environmental Inspector (TM EI [S.D]) ○ Regulatory Lead [K.M] ○ Construction Manager [T.A] ○ Indigenous Monitor [M.J] <p>KLTP gave DFO a reminder of muster points and emergency procedures. TM provided an overview of on-going works at the WMT including:</p> <ul style="list-style-type: none"> • Upland activities (road widening; western water treatment plant; Eastern and western water treatment plants are now operational); • Onshore activities (piping and concrete demolitions works to support deep soil mixing; deep soil mixing); • Nearshore/in-water (works on arc cells 7a and 8a); • Offshore (pile driving BD piles 5 and 6; works on loading platform cells LP1 and LP2). <p>Other items discussed:</p> <ul style="list-style-type: none"> • TM poured concrete to cap a few piles last week in offshore waters; measures to contain concrete worked well; no issues to report. • Triton completed a fish salvage in arc cells 6a and 9a. Species such as pipefish, sculpins, crab were salvaged. • TM installed a fish exclusion net to prevent fish from entering arc cell 6a, since arc cell 6a will only be infilled in 2-3 weeks. DFO suggested that, prior to infilling, Triton conduct another fish salvage to verify that no fish have managed to enter the cell. • Weight has been added to the deepest three rings of the bubble curtain to bring the rings closer together; based on underwater noise monitoring measurements, having the rings closer together appears to further reduce underwater noise at depth during impact pile driving. • TM is constructing a new bubble curtain (consisting of two 'L-shaped' sections) that will be placed on the seafloor to form a square around the base of the pile and be approximately 3 m from the pile being driven, to further reduce underwater noise at depth. TM's intent is to have this additional bubble curtain completed by February 28. • TM indicated that it has not regraded the slope of the foreshore near the new dock and gangway (to reduce erosion) due to space constraints; the slope will be regraded and the polysheeting replaced by coco matting once Keller has moved (Photo 1). • TM is delaying works on the temporary marine construction office.

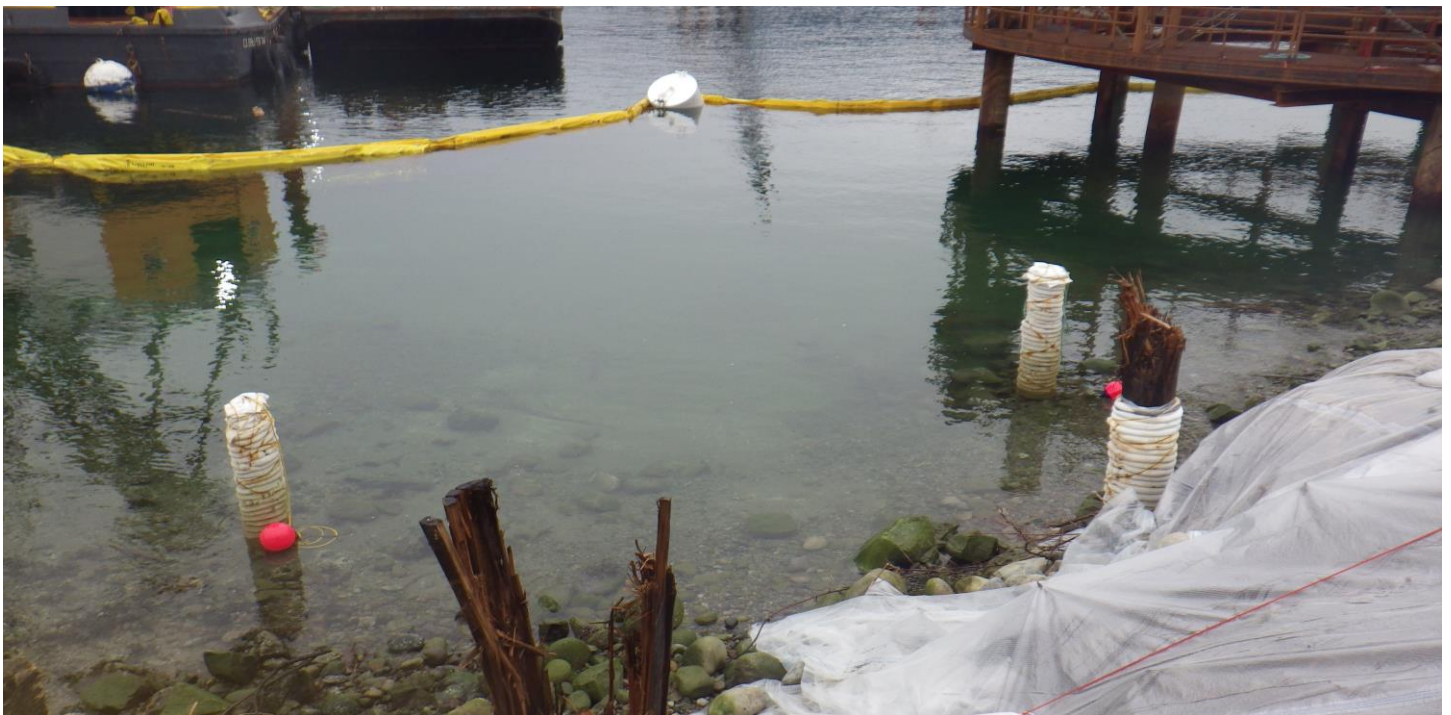
Photo 2. White sorbent rings placed around creosote piles remaining from demolition of small utility dock. Piles to be removed at a later date.

<p>absorb creosote from the piles (Photo 2). These remaining piles will be removed at a later date.</p> <ul style="list-style-type: none"> • Observed deep soil mixing columns (Photo 3) and sediment and erosion control measures in place (Photo 4). • TM EI indicated that the eastern section of the yellow turbidity curtain will be replaced in a few weeks; the turbidity curtain only has an approximately 4-6 month lifespan.
<p>1115</p>	<p>Visit to the DB General</p> <ul style="list-style-type: none"> • The TM EI showed DFO the new bubble curtain (Photo 5). • DFO observed a SCUBA diver from Hydra Marine [T.H] on site to inspect the bubble curtain to ensure it is functioning as designed prior to the start of impact pile driving for BD 5c. • DFO spoke to a KLTP representative [A.P] who is responsible for monitoring the gauges on the manifold for the bubble curtain to verify flow and pressure. KLTP confirmed that no issues were noted during installation of one of the curtains the previous day. DFO scanned the bubble curtain checklist being used by KLTP to verify functioning of the curtains. • DFO observed two representatives from Hemmera setting up underwater noise monitoring equipment for impact pile driving. Hemmera provided DFO an overview of the underwater noise monitoring software its uses to record noise levels measured by both hydrophones (Photo 6). DFO clarified that DFO recommends the deepest hydrophone be placed <i>within</i> two meters of the seafloor, and not <i>at</i> two meters of the seafloor. • Hemmera confirmed that there are four marine mammal observers on-site to monitor for marine mammals and that the marine mammal exclusion zone is currently set to 1 km from the pile; the harbor seal specific exclusion zone is 150 m from the pile. • The TM EI confirmed they are adhering to the more conservative underwater noise threshold of 207 dB during impact pile driving as a precautionary measure. • TM mentioned they are looking at the potential applicability of underwater acoustic deterrents for seals to discourage them from entering the exclusion zone (i.e., within 150 m of the pile for harbour seals) prior to or during impact pile driving; seals present within the exclusion zone regularly delay impact pile driving and delay overall construction. • DFO intended to observe the DB General conducting impact pile driving during the site visit, but pile driving was delayed due to seals.

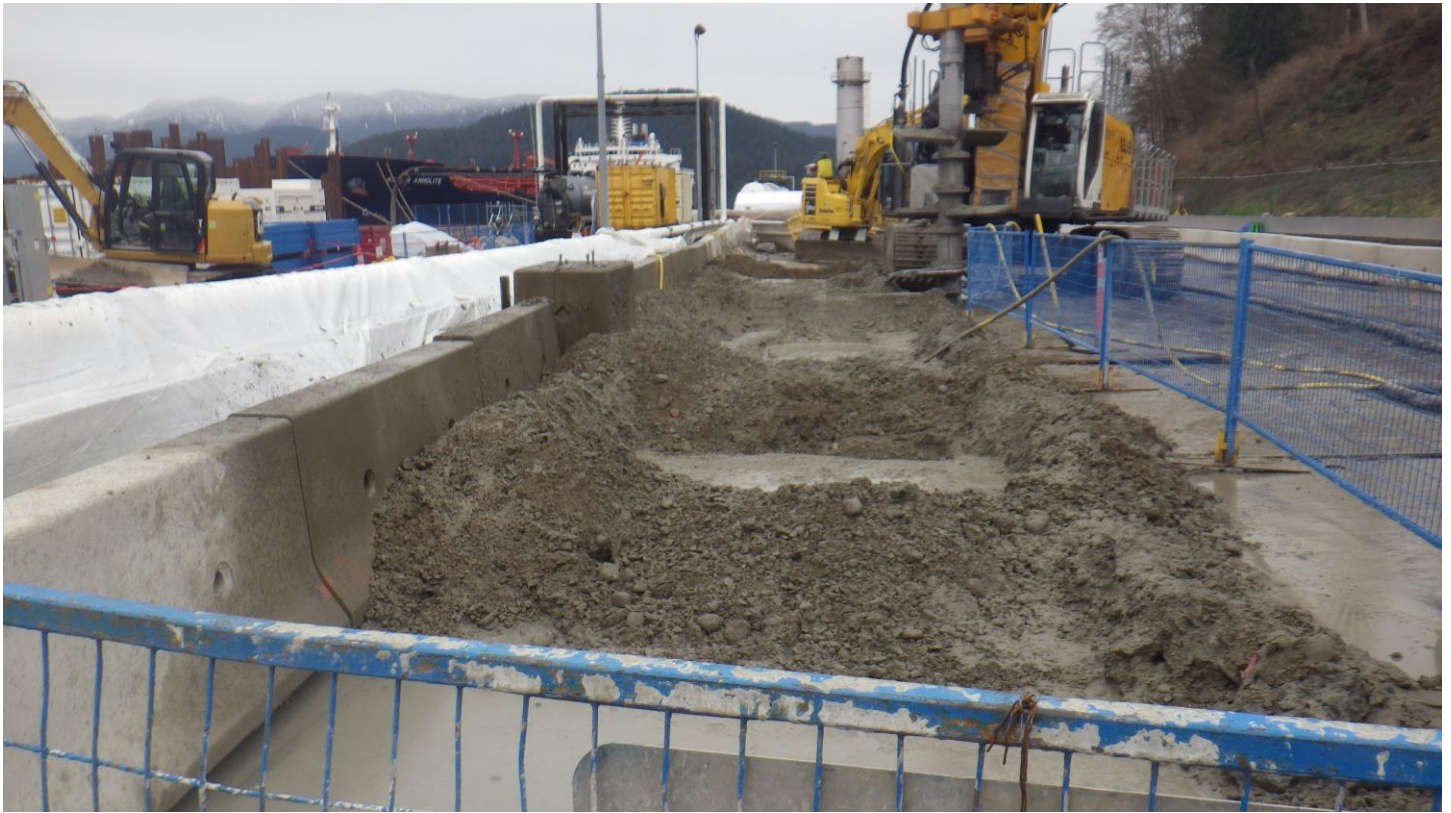
Photo 3. Deep soil mixing columns along foreshore.

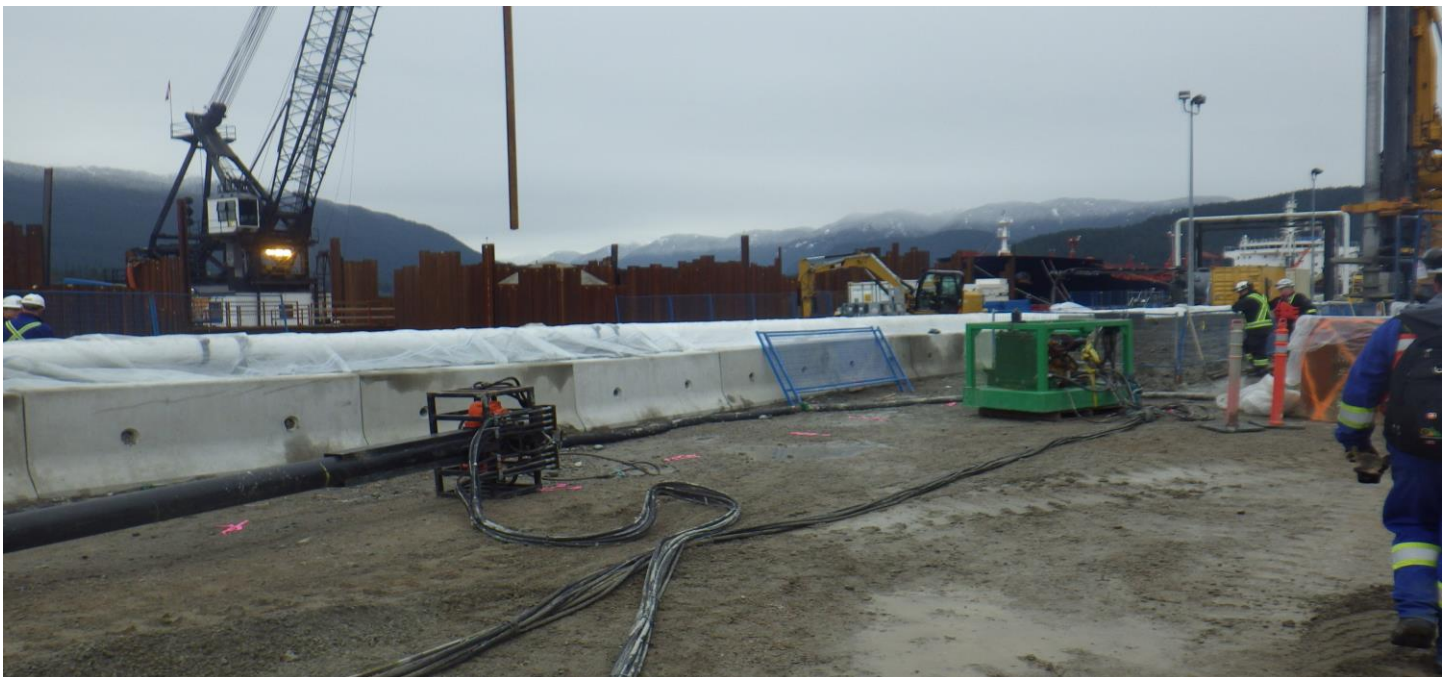
Photo 4. Lock blocks in place to prevent erosion of sediment-laden water or other materials into the marine environment from on shore works.

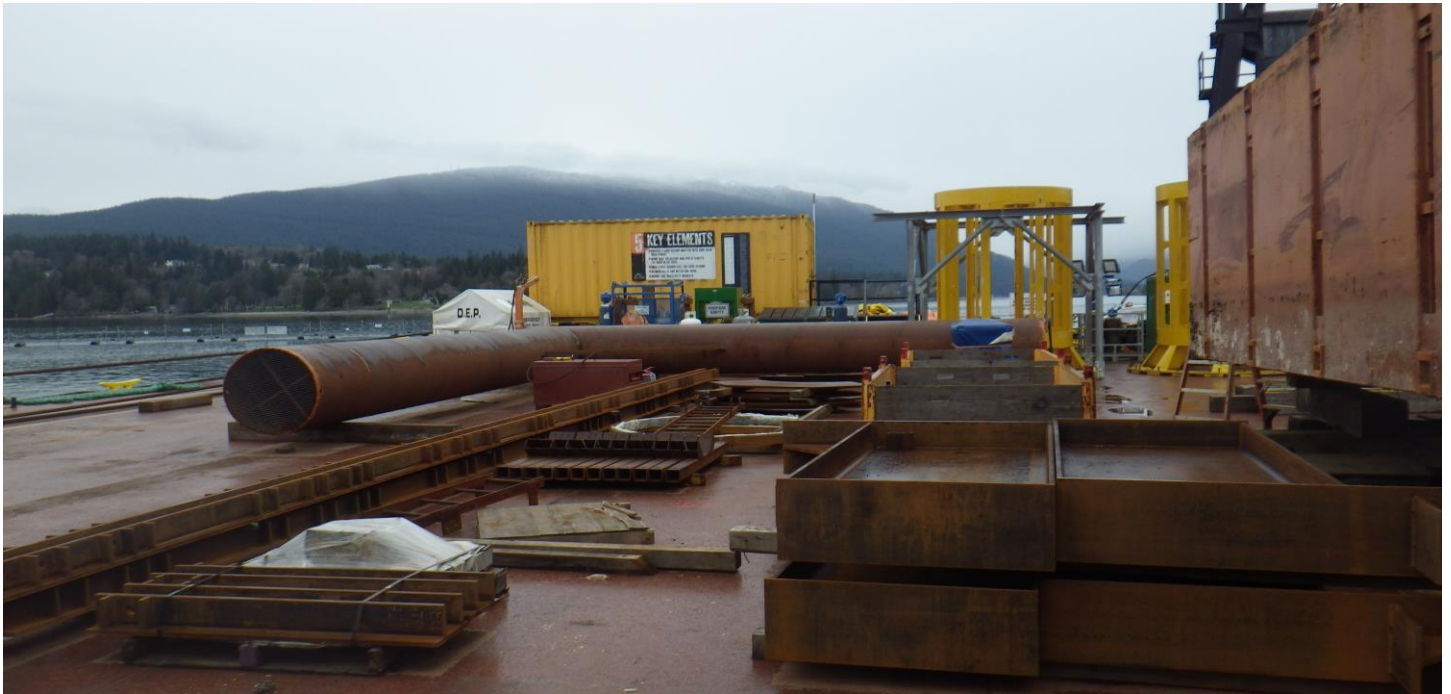
Photo 5. Base of the new bubble curtain that will be placed on the seafloor to further attenuate underwater noise at depth during impact pile driving. The new curtain will consist of two ‘L-shaped’ sections that join together to form a square.

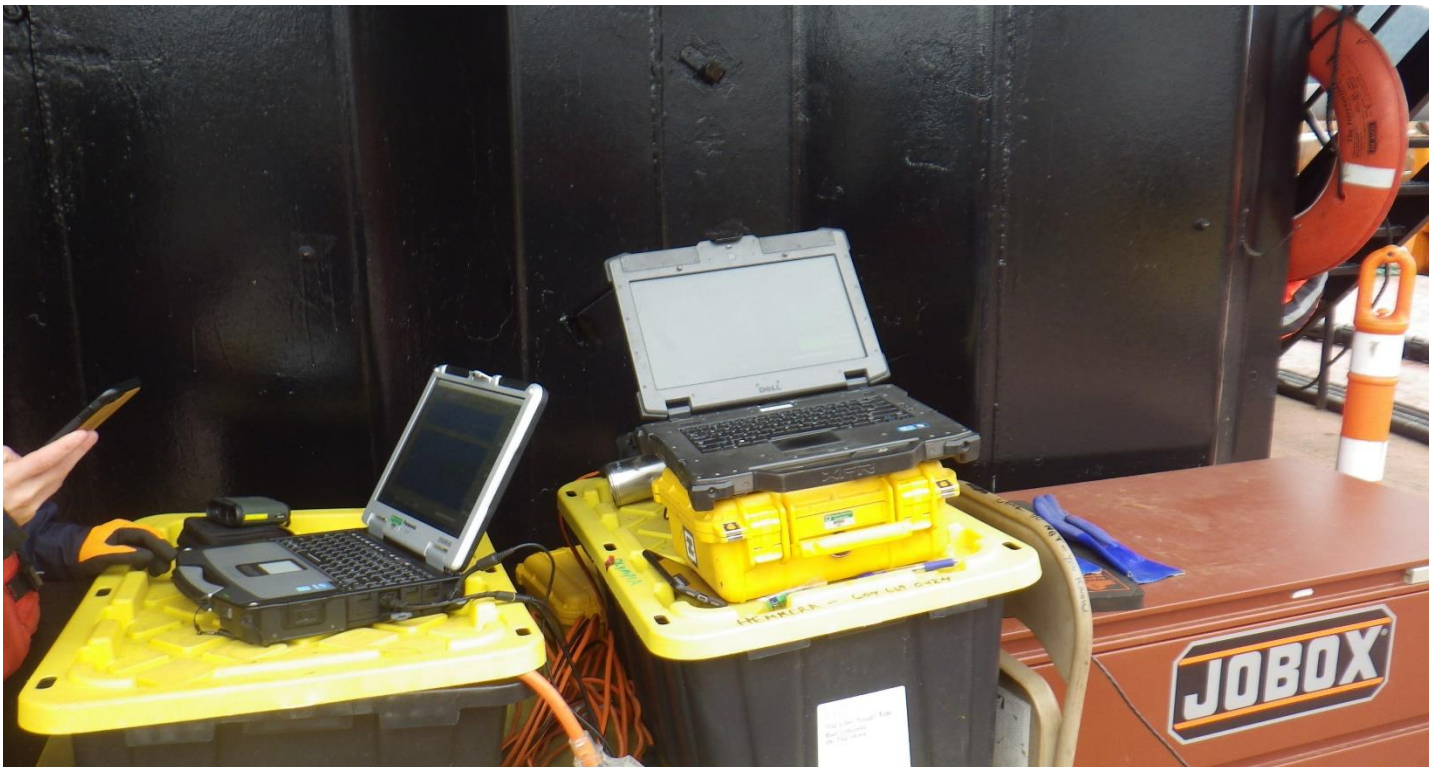
Photo 6. Computers used to record underwater noise levels measured by two hydrophones (one at mid-depth and one within two meters of the seafloor) during impact pile driving.
