Site Visit Report: SV-2020-01-28

## Trans Mountain Expansion Project – Westridge Marine Terminal Visit

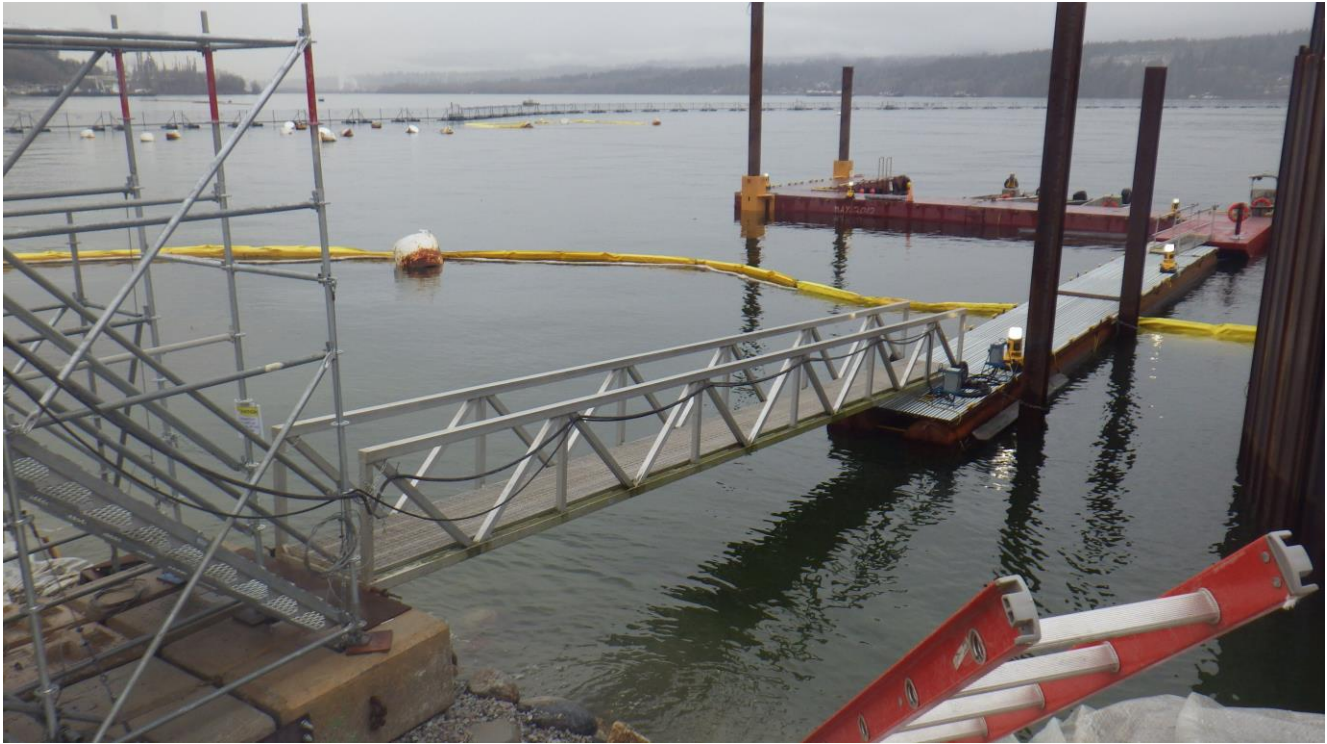
**Photo 1. Gangway and flexi-float dock constructed to replace small utility dock and will be removed after marine construction office is built.**

1025	Arrive at the Westridge Marine Terminal.
1025-1130	<p>Walk along foreshore</p> <ul style="list-style-type: none"> <li>• observed upland works to construct western water treatment plant. Treatment plant will be commissioned this week. The TM EI indicated that works to increase the capacity of the eastern water treatment plant will occur in mid-February 2020.</li> <li>• observed new temporary flexi-float dock and gangway, which was recently installed following demolition of the small utility dock in late 2019 (Photo 1). To reduce erosion, the TM EI indicated that the foreshore near the new dock and gangway will be re-graded to a 2:1 slope and the white polysheeting currently covering the</li> </ul>

<p>shoreline (Photo 2.) will be replaced with coco matting. The TM EI indicated that the flexi-float dock and gangway will be removed once the marine construction office is built, as the office's design includes a dock and gangway.</p> <ul style="list-style-type: none"> <li>observed areas of turbid water located within the yellow turbidity curtain (Photo 3); curtain appears to be functioning as designed. The TM EI pointed to an area along the shoreline that will be replanted with coco matting as this may be the source of the turbid water.</li> <li>observed a few creosote piles remaining in the nearshore following demolition of the small utility dock. The TM EI confirmed that the piles were too damaged to be removed at the time, but that the piles will be removed shortly. Observed sheen (likely creosote leaching from the piles) on the surface of the water. TM indicated that it would put sorbent rings around the piles to absorb creosote that leaches from the piles.</li> </ul>

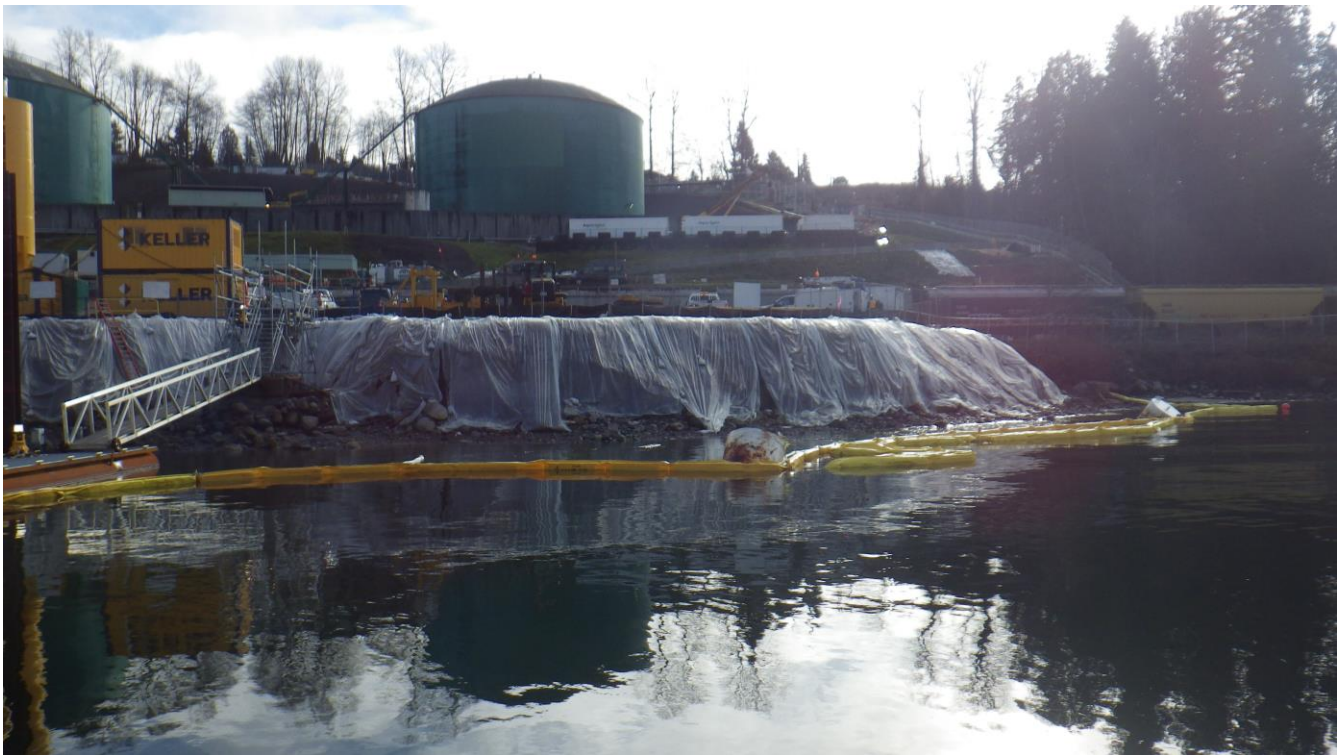
**Photo 2. Polysheeting that will be replaced with coco matting to reduce erosion.**

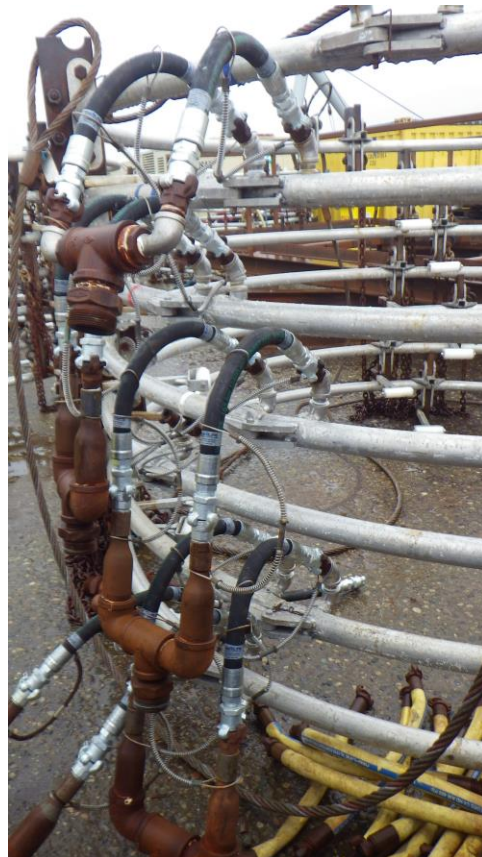
**Photo 4. New hoses on bubble curtain rings.**

1130-1245	<p>Visit to DB General</p> <ul style="list-style-type: none"> <li>TM EI showed DFO the new hoses being installed on the bubble curtain rings (Photo 4) that are deployed during impact pile driving; the new hoses are lined with metal and are designed to not bend or kink and in turn, provide a consistent air supply to the rings.</li> <li>KLTP provided DFO an overview of the new checklist that will be completed to verify functioning of the bubble curtains prior to impact pile driving. KLTP indicated that this checklist is included in the Offshore Impact Pile Driving Bubble Curtain Standard Operating Procedure.</li> <li>DFO intended to observe the DB General conducting vibratory pile driving during the site visit, but pile driving was delayed.</li> </ul>
1245-1300	<p>Walk along foreshore</p> <ul style="list-style-type: none"> <li>DFO and IAMC IM verified that the sediment fence that had not been keyed in properly during DFO's previous site inspection had in fact been re-installed. The TM EI also showed DFO and the IAMC IM that an additional sediment fence had been installed in the same area to further enhance sediment and erosion control.</li> </ul>
