# MARINE TRANSPORTATION SAFETY INVESTIGATION REPORT M21P0297

## **LOSS OF CONTAINERS OVERBOARD AND SUBSEQUENT FIRE**

Container vessel *ZIM Kingston*  
La Perouse Bank, British Columbia  
21 October 2021

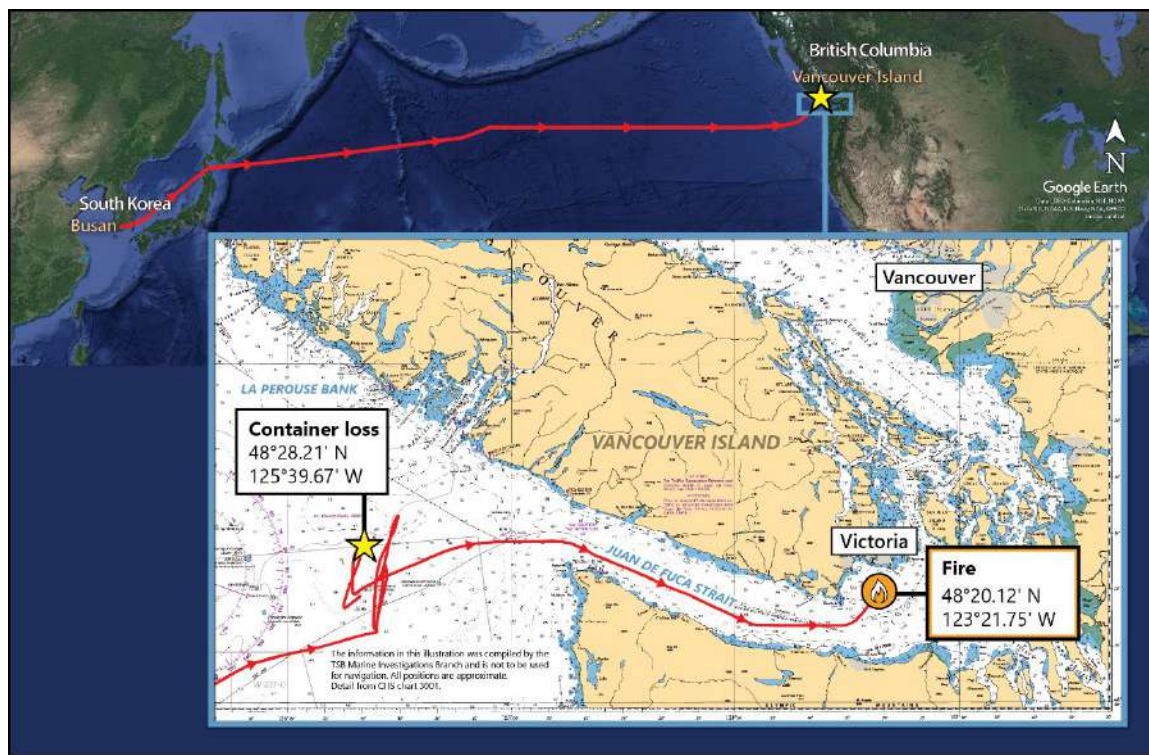
Figure 2. Satellite image and chart showing the *ZIM Kingston's* position at the time of the heavy rolling and container loss (Source of main image: Google Earth, with TSB annotations. Source of inset image: Canadian Hydrographic Service Chart 3001, with TSB annotations)

At 1800, the vessel began drifting northward for the 3rd time with the bow oriented southwesterly into the waves. The master was still on the bridge but was resting, and the third officer was the officer of the watch. At around 2229, the winds were southeasterly at 42 knots and the waves were 5 to 6 m from the southwest. The bow was oriented west-southwesterly into the waves, and the vessel was drifting northward at 2.2 knots. At this time, the vessel experienced heavy rolling and pitching that lasted for about 1.5 minutes. The vessel rolled heavily to both port and starboard approximately 4 times, with the maximum roll being 36°. The vessel was in position 48°28.21' N, 125°39.67' W at the time of the heavy rolling (Figure 2) and the crew noted that some containers had been lost.

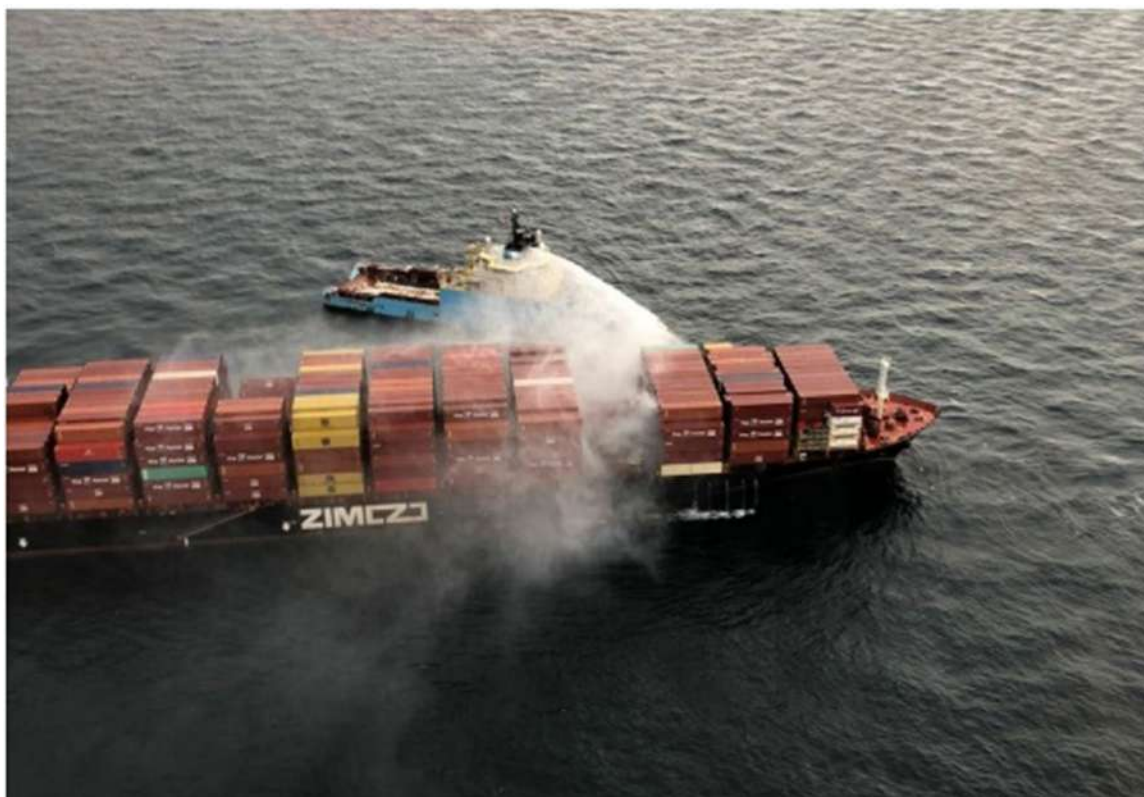
Figure 3. *Maersk Trader* performing boundary cooling (Source: Resolve Marine)

Resolve Marine also contracted 2 privately owned vessels, the *Maersk Trader* and *Maersk Tender*, that happened to be berthed in Victoria at the time. Both are foreign-flagged offshore supply vessels with firefighting class 1 systems. They arrived at the occurrence site at around 0100 on 24 October and joined the *Seaspan Raven* in the boundary cooling operations (Figure 3).

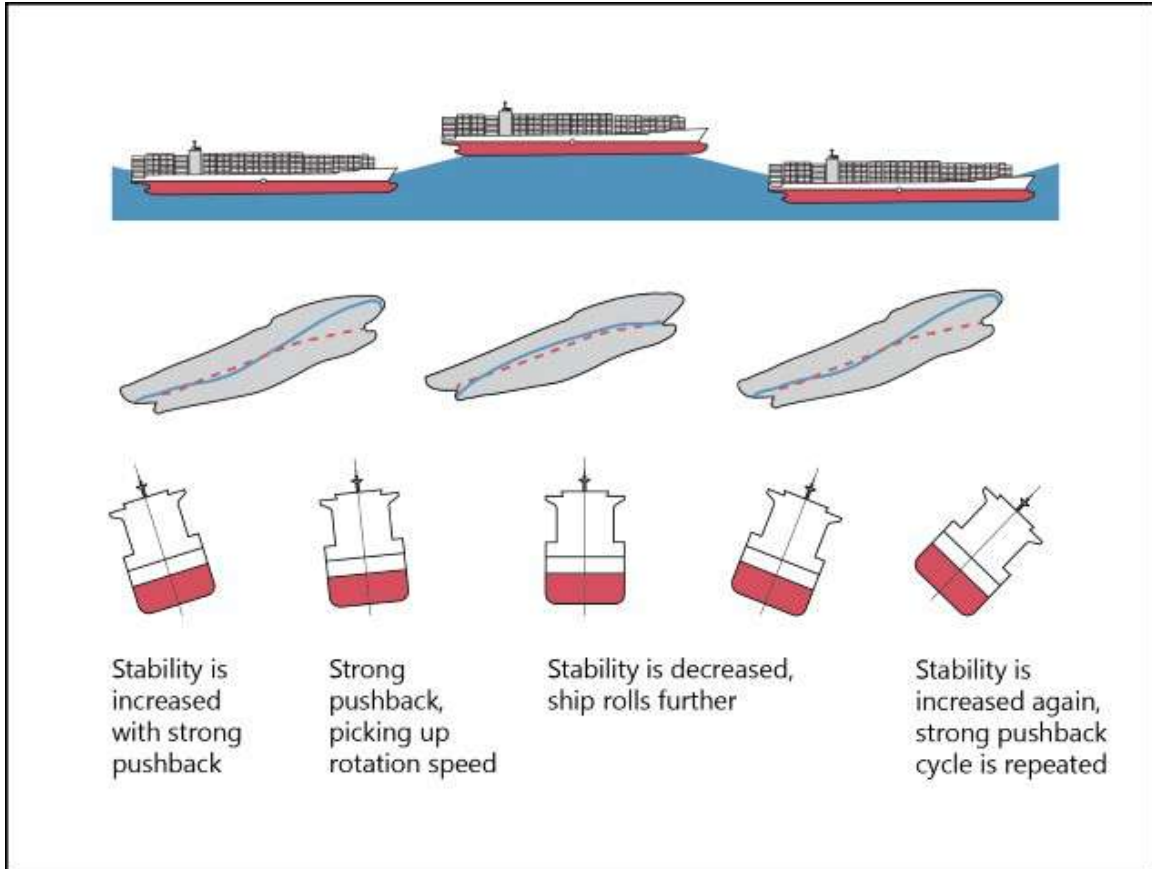
When the vessel is on a wave crest, stability is reduced and the vessel will roll over to one side, but when the wave trough reaches midship, the increased stability quickly pushes the vessel to an upright position. Once another wave crest reaches the midship position, stability is again reduced, which results in the vessel rolling in the opposite direction, but when the wave trough reaches midship, it will quickly push the vessel back upright again. This sequence is illustrated in Figure 14.

This fluctuation in stability is accentuated in vessels with a flared bow and flat transom stern, characteristics that are common for container vessels because they maximize deck cargo carrying capacity while minimizing water resistance through the use of fine hull lines. The fluctuation in stability is also accentuated when the vessel is travelling in waves high enough to cause a significant change in underwater hull form.

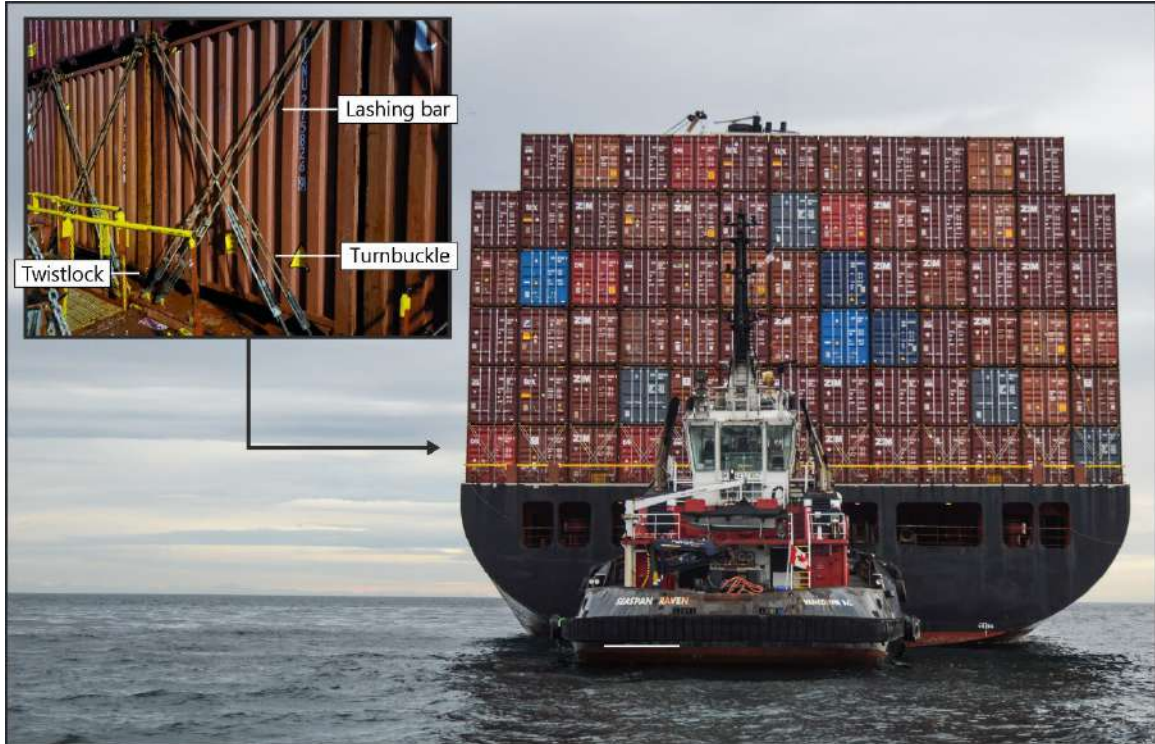
Figure 23. Lashing components used to secure containers on the *ZIM Kingston* (foundations not shown) (Source for main and inset images: TSB)

On the *ZIM Kingston*, similar to most container vessels, the 40-foot containers were secured on deck using components that included lashing bars, turnbuckles, twistlocks, and deck-mounted foundations (Figure 23). Twenty-foot containers were secured using similar components, as well as midlocks that secured the 20-foot containers end-to-end. The foundations were fixed to the deck or deck hatch covers and served as blocks on which the container stacks rested. The lashing bars were used in combination with turnbuckles and twistlocks to secure the containers on the lower 2 to 3 tiers.<sup>63</sup> The containers in higher tiers were secured one on top of the other using twistlocks. Containers beside each other were

not secured together, meaning that each container stack was independent of its neighbouring stacks.

Container securing components have safe working loads that are typically 50% of the components' minimum breaking strength. The minimum breaking strength is defined as the force at which the component will fail and is determined by the weakest point of the component. Most manufacturers will design components so that there is some unknown degree of strength beyond the minimum breaking strength; however, this is not guaranteed. The ratings for the container securing components in use on the *ZIM Kingston* are shown in Table 5.
